# Long-term determination of shoreline changes along the coast of Lagos

Article · July 2020

**Abstract:** Analysis of shoreline changes is an important indicator in the study of coastal erosion and/or accretion. It aids in understanding the spatio-temporal trends in the changes triggered by natural processes and human impacts. The construction of two breakwaters (East and West moles) between 1908 and 1912 at the entrance to Lagos harbor inhibited the natural flow of the longshore drift, hence it accelerated erosion rate especially in the Victoria Island area while areas on the west of the breakwaters were accreting. This study relied on archival maps of 1900 – 1964 and satellite imageries of 2001–2016 to determine and visualize the magnitude of erosion and accretion along the coast of Lagos State. The shoreline positions at various epochs were extracted from the maps and satellite imagery by vectorization. The magnitude of change was determined by calculating the differences in the shoreline positions measured along vertical line segments spaced at 200-meter intervals. Then, the shoreline positions were plotted graphically. The analysis shows a trend of accretion on the western s

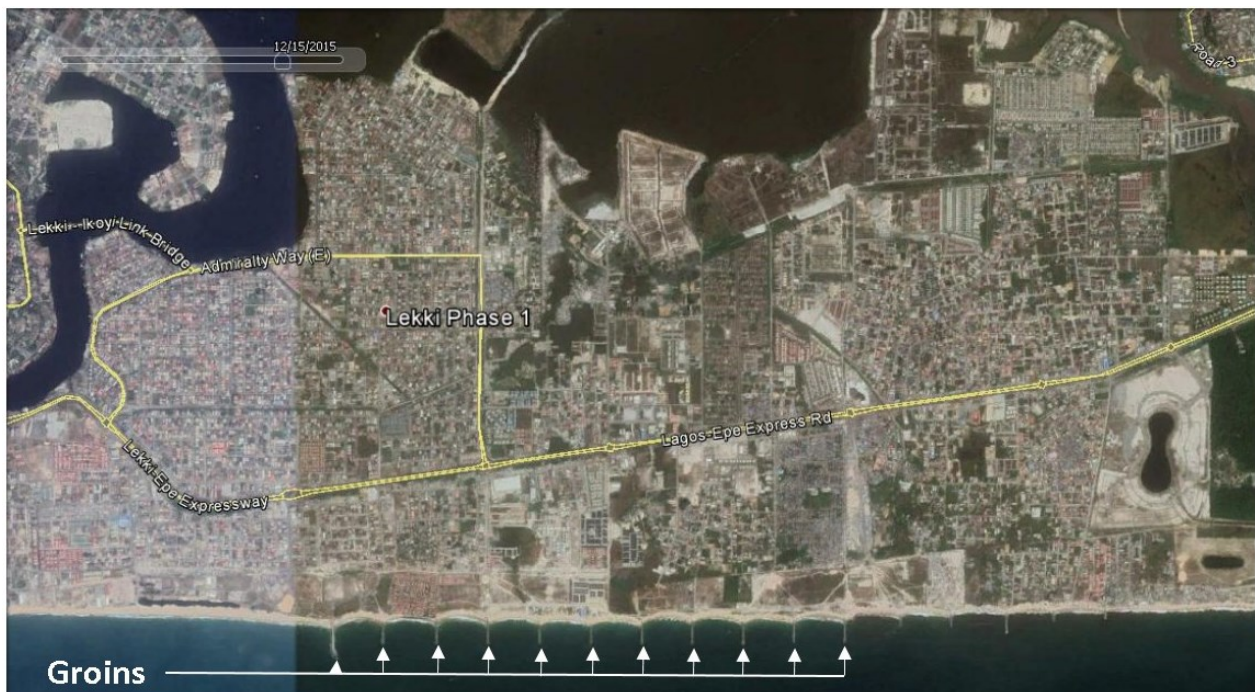
Figure 9: Newly constructed groins off the Lagos coast (Imagery source: Google Earth, December 2015)

Figure 9 shows some of the newly constructed groins along the coast. These groins were constructed perpendicular to the coast to interrupt the water flow and limit the movement of eroded sediment being transported away

from the Victoria Island area. This led to accretion/deposition on the upper end and erosion on the lower end. The areas between the groins are observed to be

side of the coast from Victoria Island going towards Orimedu, erosion rates as high as 26.17m/yr were measured during the 2012-2016 period. This has been somewhat confirmed by the construction of several perpendicular groins downdrift on the Lekki Peninsula since 2013. According to Obiefuna et al. (2017), these newly constructed groins are apparent confirmation of existing serious erosion.

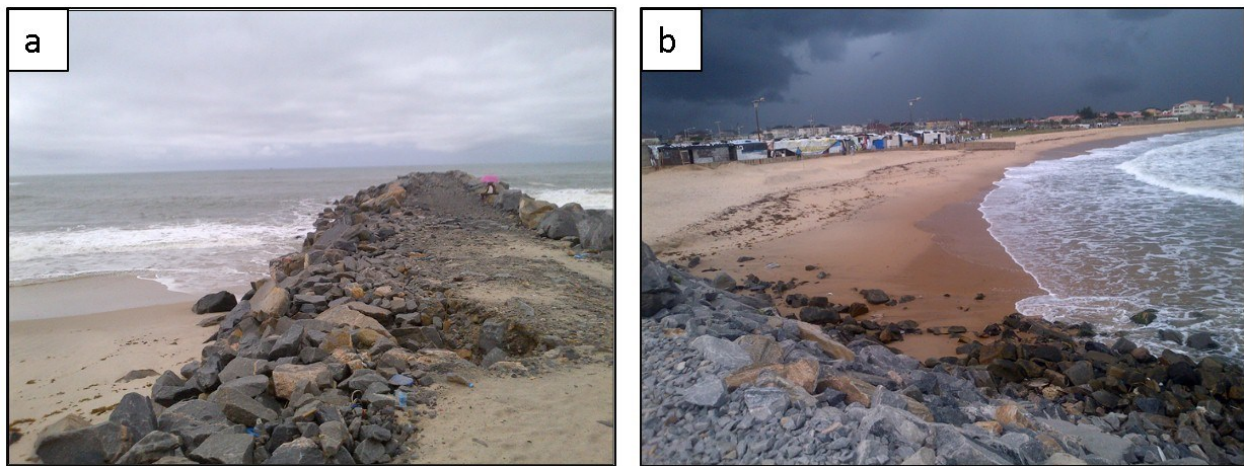
**Figure 10: (a) A view down the length of one of the groins (b) Ongoing erosion alongside one of the groins constructed on the Lagos coast (Field survey, October 4, 2017)**

u-shaped or crenulated. This shape is a result of despoliation by erosive forces acting within the groin fields (Figure 10).
