## **Flood Abatement on Lagos City Streets: A Survey of Street Planning and Design Parameters for Effective Drainage**

**Jerry N. Obiefuna**

Department of Architecture, University of Lagos,  
Akoka, Lagos.

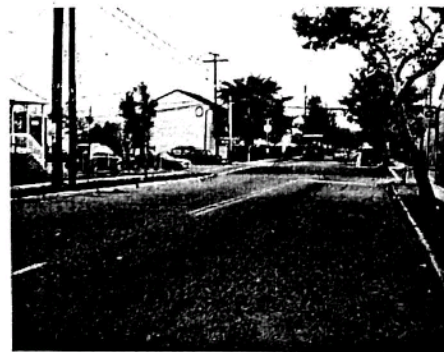
Except on a segment of University Road, Ransome Kuti Road, Ogunlana Drive and Adeniran Ogunsanya St., all others have triangular cross sections with discernible slopes of the range 2-4%. This is more pronounced on 4-lane divided roads such as Ejigbo/Egbe Road and Awolowo Way. Here the median is the apex with the pavement sloping uniformly sideways except at superelevated sections. Save for the 4-lane roads, most of others especially Ogunlana Drive and Ogunsanya Street exhibit irregular or

Plate1. Street with convex crown and slope.

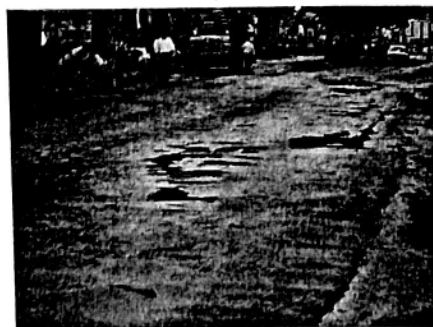
uneven cross slope with depressions towards the edges or curbs. In some of these instances, the street edges or curbs are at higher levels than the intervening pavement between them and the apex of the road (Plates 2, 3, 4). Apart from Awolowo Way and University Road, many of the roads/streets exhibiting uneven cross slope have witnessed sporadic maintenance in some sections in recent times. It could not however be determined if the depressions in cross slope are attributable to improper maintenance or differential settlement.

Uneven cross-slope and depressions are evidently some of the prime contributors to ponding on the street pavement. Clearly, it was observed that streets in relatively flat terrain of Surulere and Akoka rely heavily on cross slope for drainage in comparison with those in undulating terrains of Isolo, Ejigbo and Ikeja.

- c. Inconsistent profile or roller-coaster longitudinal slope between the crest and sag curves occur on a number of these streets with the exception of Awolowo Way. This is most pronounced on Aswani Road and Kogberegbe Street, Isolo. This situation aids ponding on many segments of the road pavement [Plates 2, 3].

Plate 2. Irregular Cross and longitudinal slopes resulting in ponding.

Apart from the piecemeal resurfacing, a batch of selected streets drawn from some local government areas can be comprehensively (i.e. in their entirety) resurfaced or rebuilt (as Ibe Road.) to their original standards or better every 5-8 years in rotation. By rotation, several streets in many areas will be covered over a period of time. Alternatively, instead of the patchwork approach hitherto used, striping down the failed sections and building back to original levels with undamaged sections can be adopted. This approach has frequently been employed in the repair of Sagamu-Benin Expressway satisfactorily.

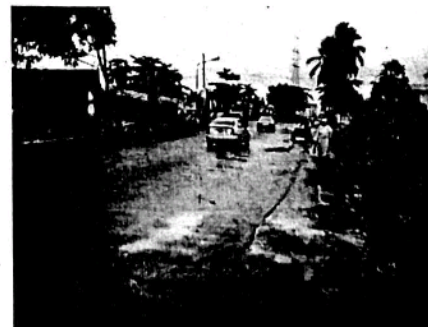
Plate 3. Ponding resulting from roller-coaster slopes.

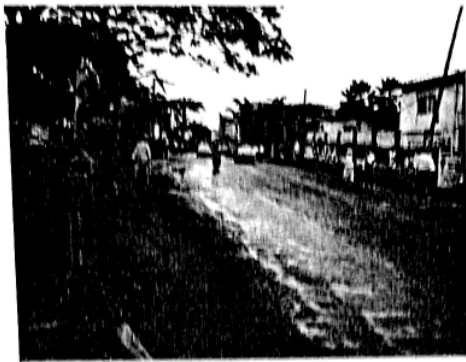
Plate 4. Street edges at higher levels than the center of street.

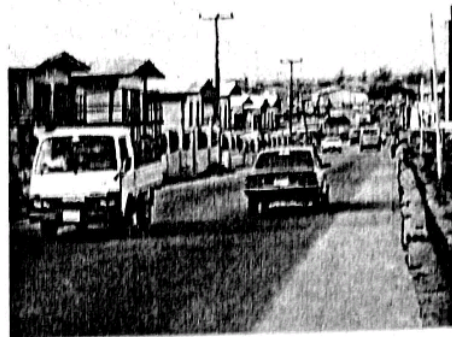
- In areas of sloping topography as in Isolo, Ejigbo and Ikeja, the streets and roads surveyed have perceivable longitudinal slope of range 3-5% which aids rapid drainage along the edges and into the channels (Plate 5).
- In relatively flat areas as in Surulere, Akoka, longitudinal slopes of the streets are hardly perceivable at a range of 1-2% as observed on University Road at Atan Cemetery and Adeniran Ogunsanya Street.
- Also streets in areas of flat terrain rely more on cross slope for drainage than longitudinal slopes.
- In flatter areas, ponding or flooding occurs more on the road pavement between the crown and the edges either

Sand drifting on the street is found deposited on pavement edges or curbs and near medians. Even on streets with side channels, this situation as it piles higher over time appears to affect the street cross section by preventing run-off from emptying freely into the channels. This is noticeable on almost all streets except Awolowo Way. This is one of the more evidence of our lack of street maintenance through street sweeping [Plates 5, 6, 7].

Plate 5. Aswani Road exhibiting fair longitudinal slope with siltation along the edges.

The removal of refuse from channels has already been suggested in Folorunsho and Awosika (2001). Timely evacuation of silt and refuse so removed however cannot be over emphasized. No benefit is served by removing refuse from the channels to let them sit on the

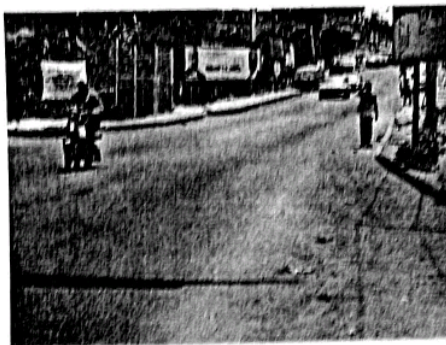
Too often, silt and refuse cleared from channels either from drainage clearance or environmental sanitation are left uncleared for long periods. These may become small dams or subsequent rains either return them to the same channel or disperse them on the road sometimes resulting in unintended floods and traffic jams.

Plate 6. University Road – siltation and non-evacuation of silt from edges.

streets. The inauguration of the Environmental Flood Abatement Gang (EFAG) by the Lagos State Government in June 2005 and the operation of the teams in local government areas has brought an improvement in clearance and evacuation.

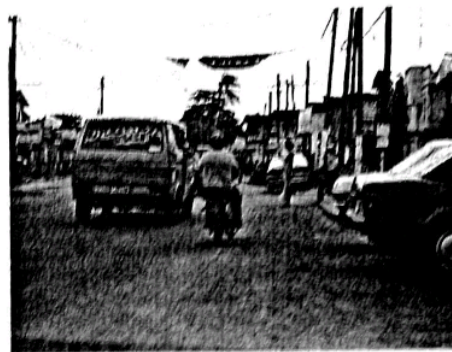
Plate 7. Bode Thomas St. – siltation on pavement edges.
